DEPARTMENT OF TRANSPORTATION
Structure Maintenance & Investigations

Bridge Number : 24C0305
Facility Carried: ALTA MESA ROAD
Location : 0.4 MI N OF SR 104
City
Inspection Date : 02-16/2010

Bridge Inspection Report

STRUCTURE NAME: LAGUNA CREEK

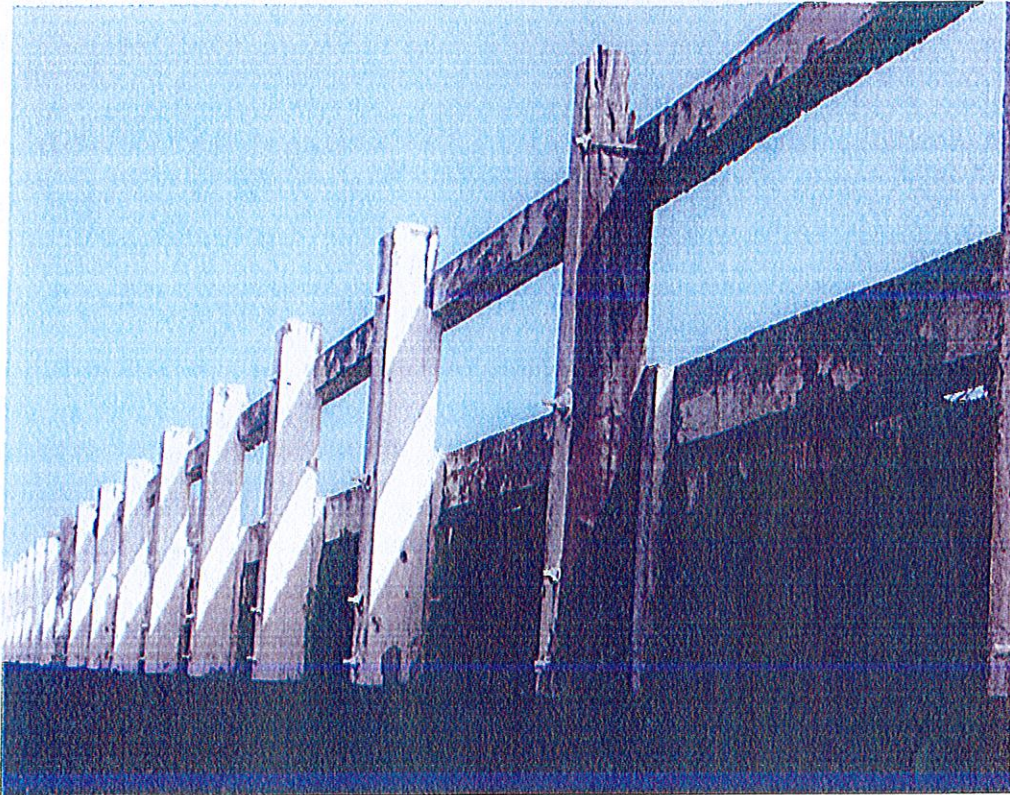
Photo No. 1

1. The third rail post on the left side from Abutment 1 is broken. See photo 1.
2. The paint system on the timber rail has peeled off and failed. See photo 1.
3. There was no identification for this structure.

The third rail post on the left side from Abutment 1 broken.

RecDate: 11/01/2006 EstCost: Replace the broken timber rail post.
 Action : StrTarget:
 Work By: LOCAL AGENCY DistTarget:
 Status : PROPOSED EA:

RecDate: 07/20/2004	EstCost:	Repaint the bridge railing.
Action : Paint-Full prep/Pain	StrTarget: 2 YEARS	
Work By: LOCAL AGENCY	DistTarget:	
Status : PROPOSED	EA:	
RecDate: 02/26/2002	EstCost:	Monitor the timber lagging at abutment 1
Action : Undefined Work	StrTarget: 2 YEARS	for signs of further failure.
Work By: LOCAL AGENCY	DistTarget:	
Status : PROPOSED	EA:

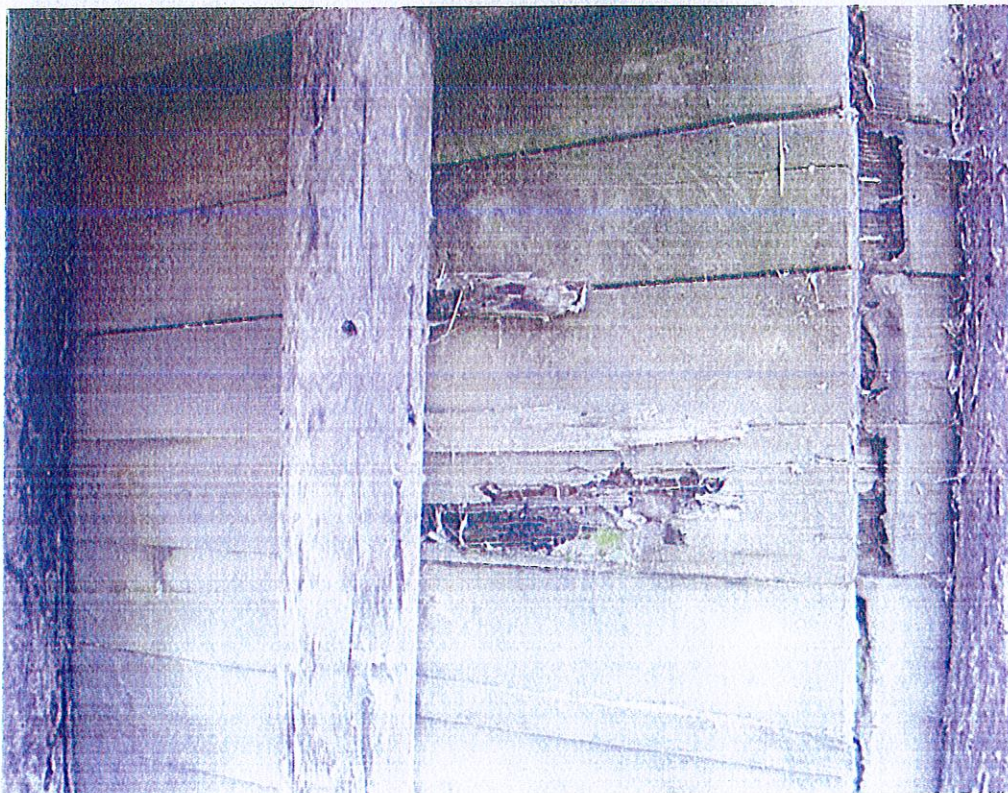
Photo No. 2

1. The Abutment 1 timber lagging is heavily rotted and failing along the front plank line. Four of the timber lagging boards are completely rotted. The ends of the left wing wall boards are completely rotted through for a length of approximately 3". See photo 2.
2. Bent cap 2 has a horizontal split about 2" deep full length. See photo 4.
3. In span 1, right side, the exterior girder has a decay zone running along a horizontal split. The split is approximately 2/3 of the way down from the top of the girder. The affected area is approximately 2" high and 4" deep into the thickness of the girder. See

Abutment 1 timber lagging is rotted.

RecDate: 11/01/2006 EstCost: Replace the rotted timber lagging at
 Action : StrTarget: abutment 1.
 Work By: LOCAL AGENCY DistTarget:
 Status : PROPOSED EA:

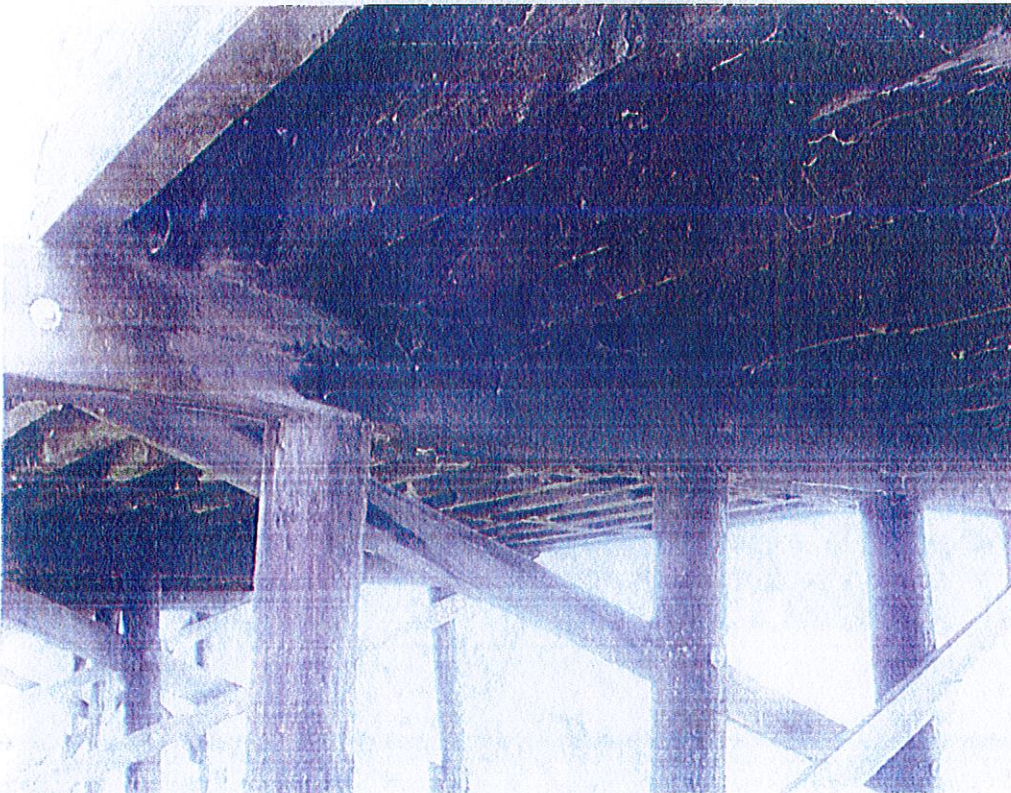
Photo No. 4
Bent cap 2 split.

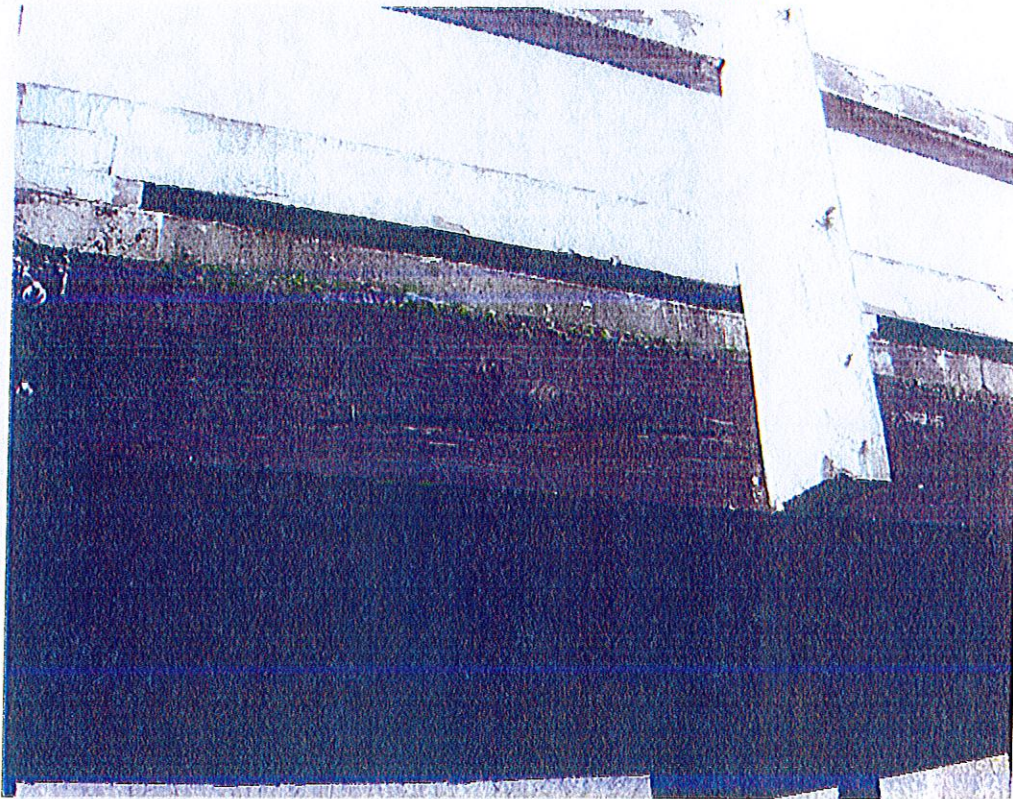
Photo No. 5

Exterior girder split on the right side at Span 2.

RecDate: 11/01/2006 EstCost: Replace the rotted exterior girders.
 Action : StrTarget:
 Work By: LOCAL AGENCY DistTarget:
 Status : PROPOSED EA:

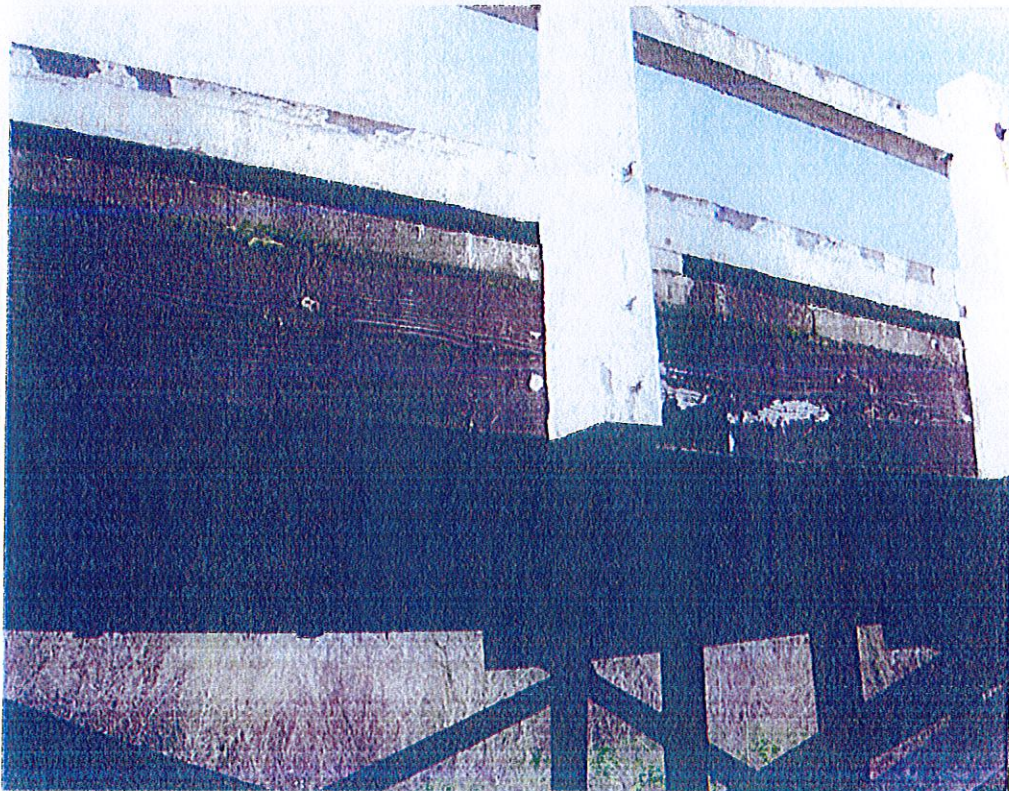
Photo No. 6

4. In span 4, right side, the exterior girder has a decay zone running along a horizontal split. The split is approximately 1/3 of the way down from the top of the girder. The affected area is approximately 1" high and 2" deep into the thickness of the girder.

Since this is the exterior girder, it only carries dead load. See photo 6.

Exterior girder split on the right side at Span 4.

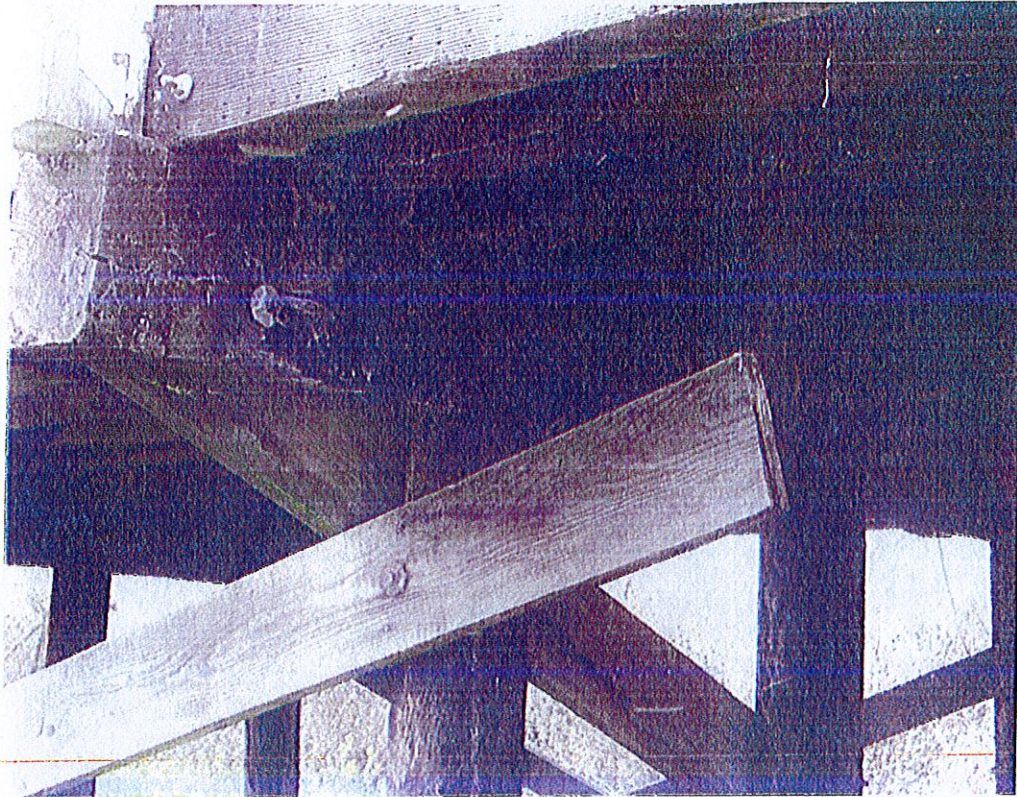
Photo No. 7

5. There is a horizontal split in the right side of Bent cap 5 about 3" deep and 12' long. See photo 7.

Bent cap 5 horizontal split.

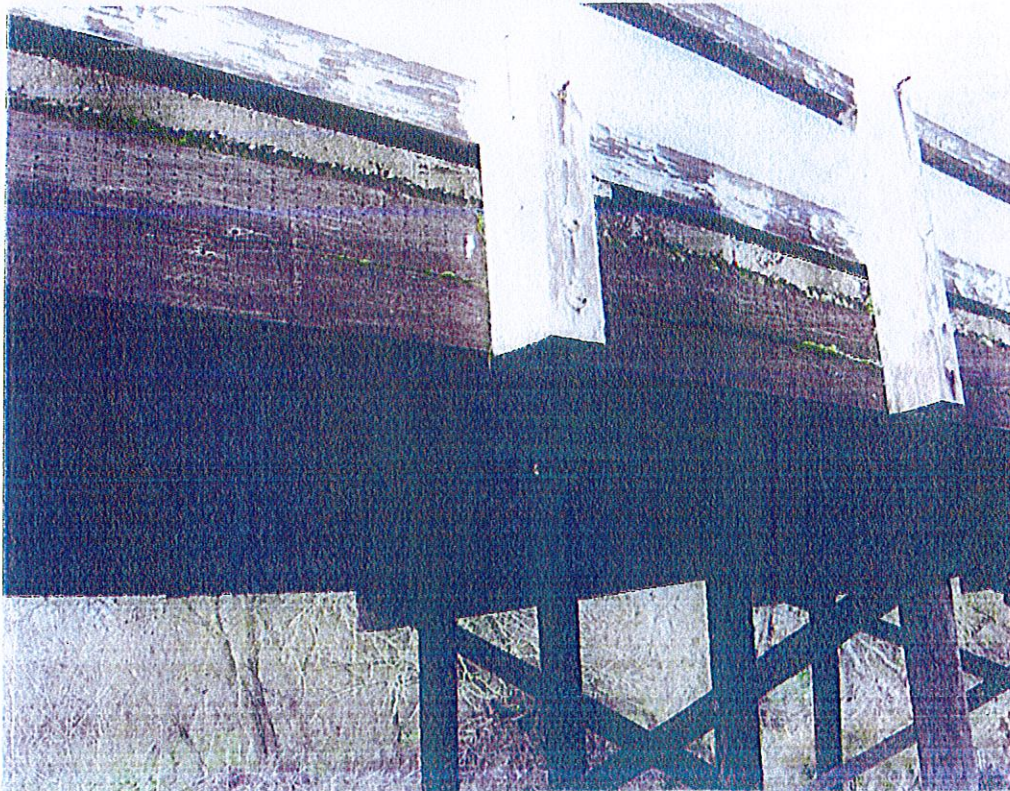
Photo No. 8

6. In Span 6, right side, the exterior girder has a decay zone running along a horizontal split. The affected area is approximately 1.5" high and 3" deep into the thickness of the girder. See photo 8.

Exterior girder split on the right side at Span 5.

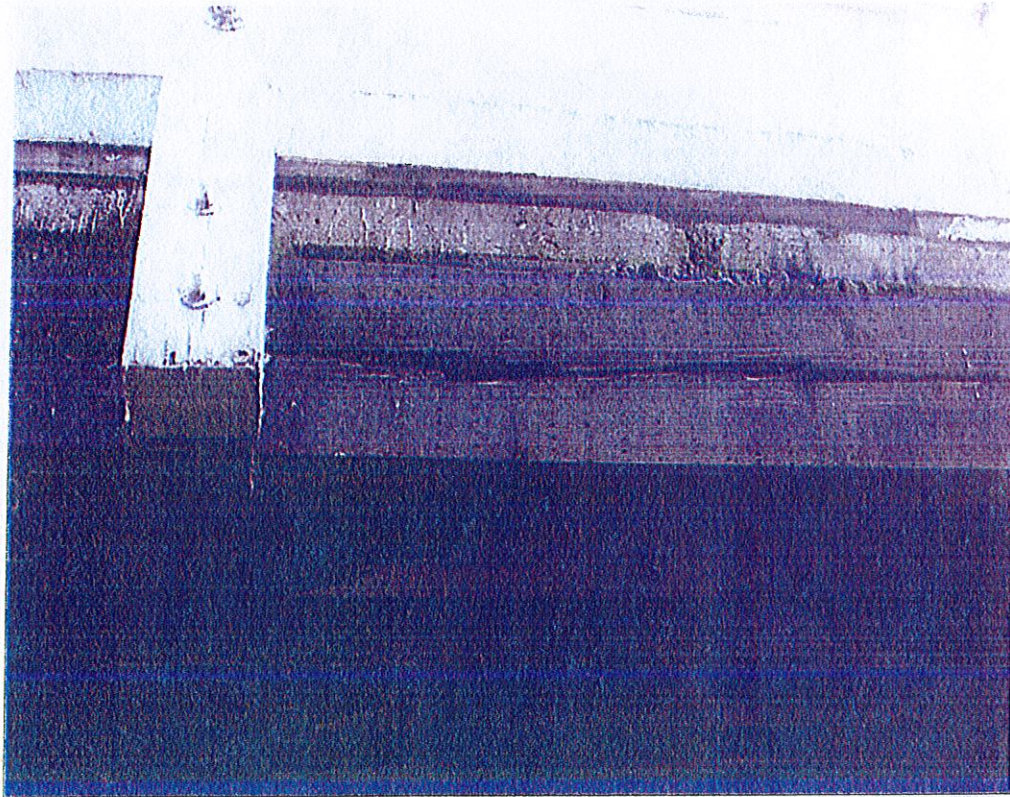
Photo No. 9

7. In Span 14, the left exterior girder has a horizontal decay zone at mid height of the girder. The affected area is up to 2' high and 4" deep. See photo 9. Also, on the left face of Girder 3, there is an area of white fungal growth approximately 9" long x 3" high. This area is decayed approximately 1/4" into the face of the girder. The white fungus continues along a horizontal crack for a total length of approximately 3'. See photo 12.

Left exterior girder in Span 14 horizontal decay zone.

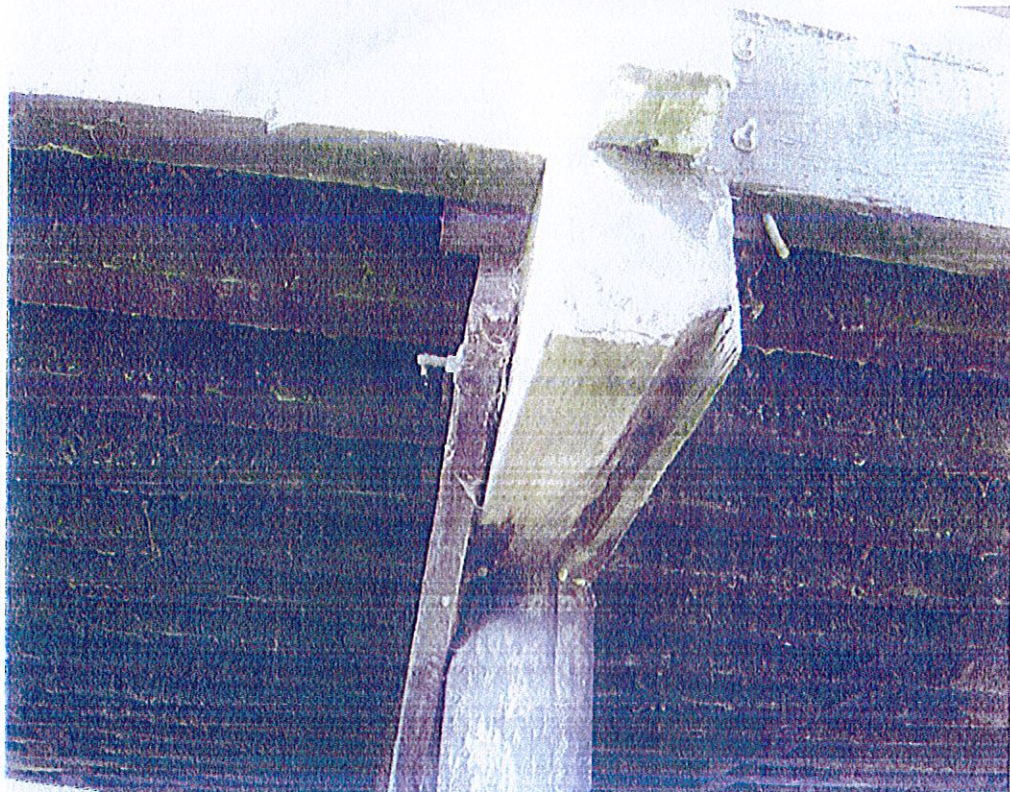
Photo No. 10

8. At Pier 15, the right end of the bent cap has a section of wood split out at the bottom corner of the cap from the end back to the pile. The voided area averages 3" wide and 3" high. See photo 10. Also, there is a horizontal split in the bent cap about 2" deep full length. See photo 11.

Bent cap 15 split.

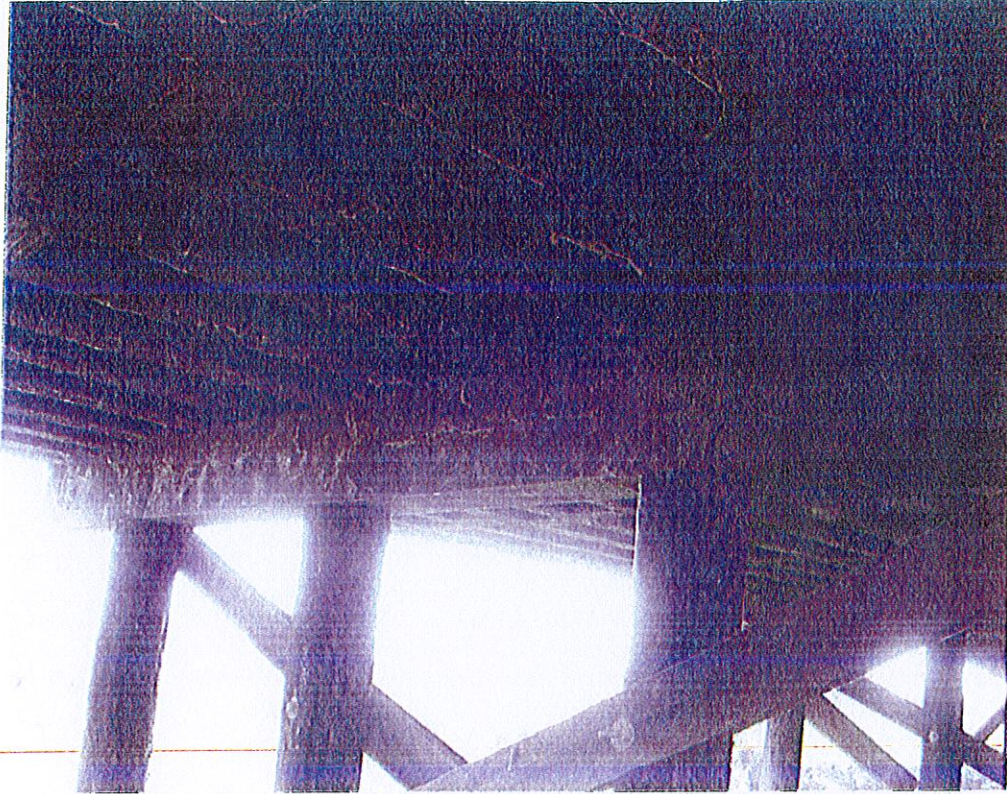
Photo No. 11
Split in Bent cap 15.

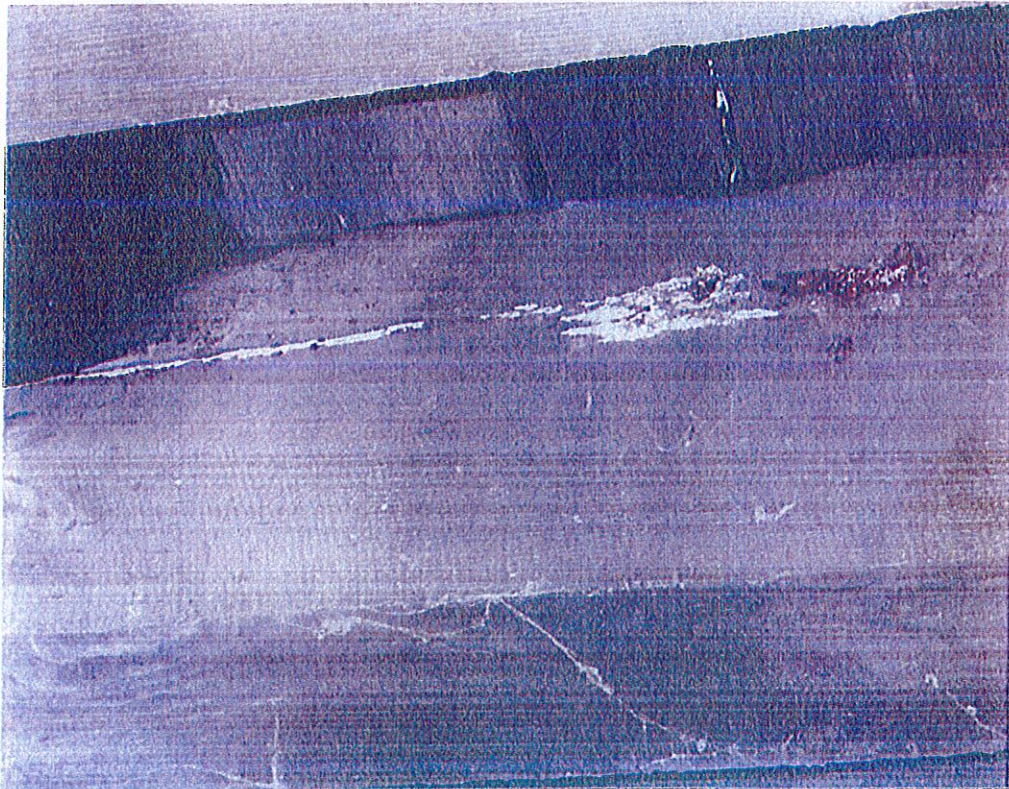
Photo No. 12
Girder 3 decay at Span 14.
