***FINAL TECHNICAL APPENDICES
VOLUME I***

***NORTH VINEYARD STATION
SPECIFIC PLAN
ENVIRONMENTAL IMPACT REPORT***

- ***NOISE ANALYSIS***
- ***BIOTIC RESOURCES***
- ***ARBORIST REPORTS***
- ***CULTURAL RESOURCES***

*Sacramento County
Department of Environmental
Review and Assessment*

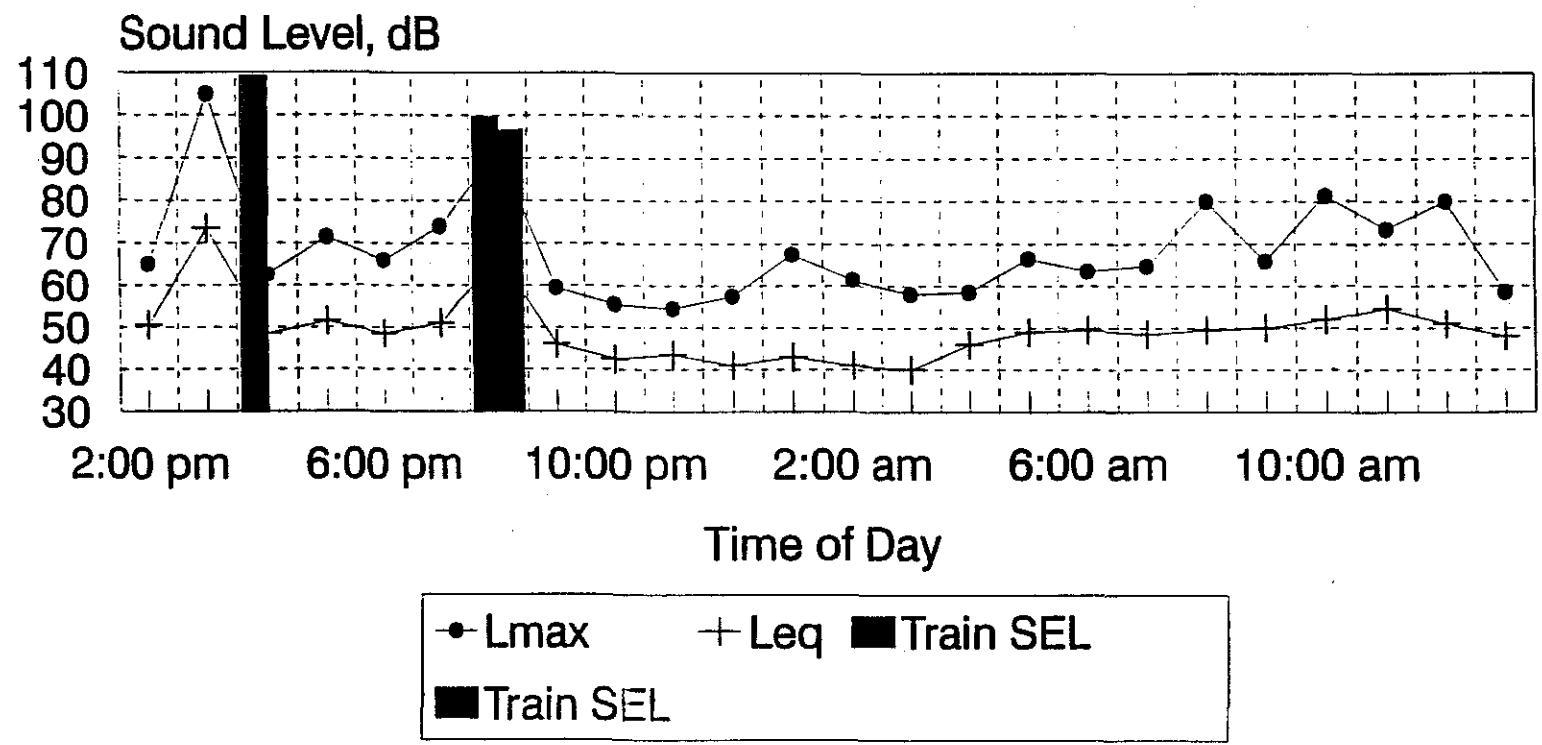
FIGURE 4

May 17-18, 1995

BBA conducted continuous 24-hour noise level measurements on the project site on May 17-19, 1995 (See Figure 2). The intent of the noise level measurements were to determine typical hourly noise levels on the project site. This monitoring site was also used to evaluate typical noise events due to operations on the Central California Traction Railroad.

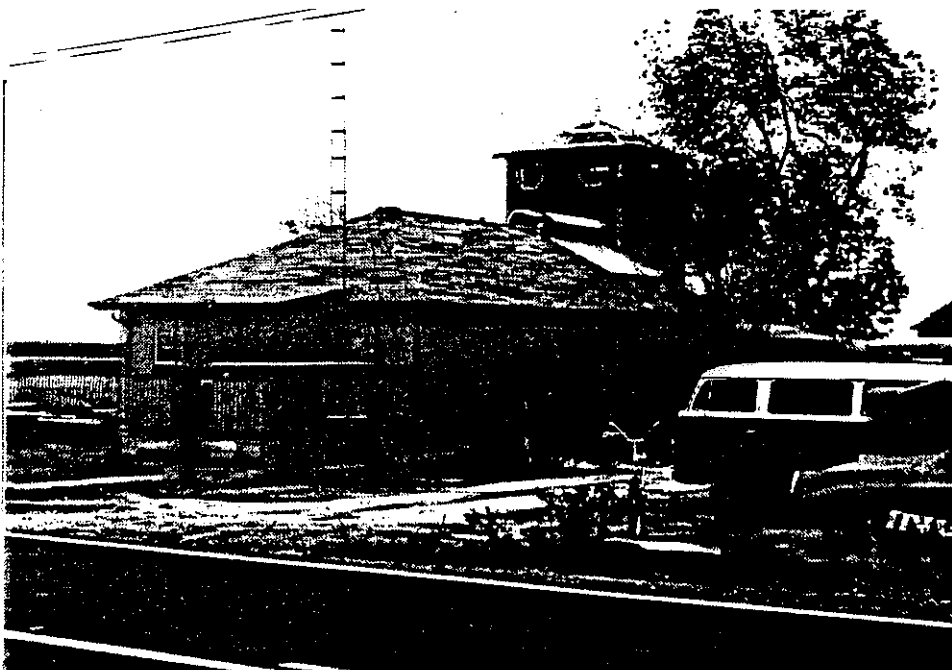
The county building record for this structure indicates a construction date of 1922. The style of roof and the date of construction identify this structure with the Craftsman bungalow style but this structure has been altered. The main Craftsman features on this structure include the hipped roof, clad in composition shingles, and exposed rafters. Alterations to this structure include a partial-width porch with a shed roof that is supported by two columns that extend from a wooden balustrade, aluminum framed windows, and T/1/11 siding covering the exterior walls.

There is a detached two-car garage with a cross gabled moderate pitched roof and clapboard siding sitting west of the house. This building appears to have the same date of construction as the house. Several other outbuildings are located south of the house. These buildings include a water tower and a modern prefabricated outbuilding. The hip roofed water tower was apparently built in the same time period as the house. With the exception of the roof which appears to be original, the water tower has been significantly modified. These modifications include two octagonal windows on the north side, a sliding glass door on the east side, and several other windows on all four sides.

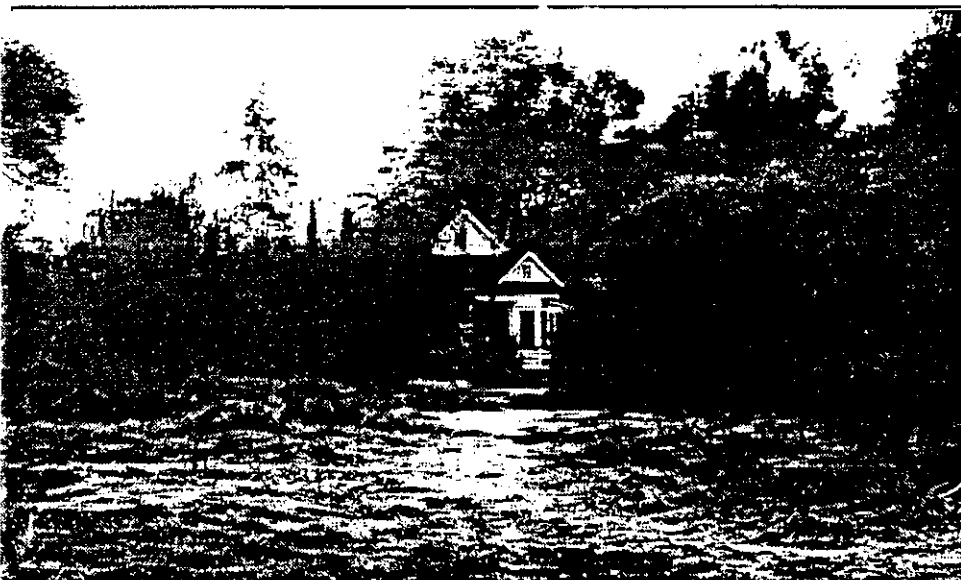
The county building record for this residence indicates construction date of 1900. This date of construction corresponds with the style, a Queen Anne Victorian. Consistent with the late construction date for this style, this one-story house has a low-pitched gable on hipped roof with a lower gabled dormer that extends above a cutaway bay window at the front (east elevation) of the house. A partial porch sits adjacent to the bay window. A more simple style of Queen Anne, this structure lacks most of the ornate features typically characteristic of this style. Some of the Queen Anne elements present on this structure include turned spindle pillars, a ballustrade with turned spindles running between the pillars, and a gable ornament. Missing from this structure are the various types of wood shingling usually decorating the gables, cover brackets above the corners of the bay windows, and patterned shingles covering the walls.

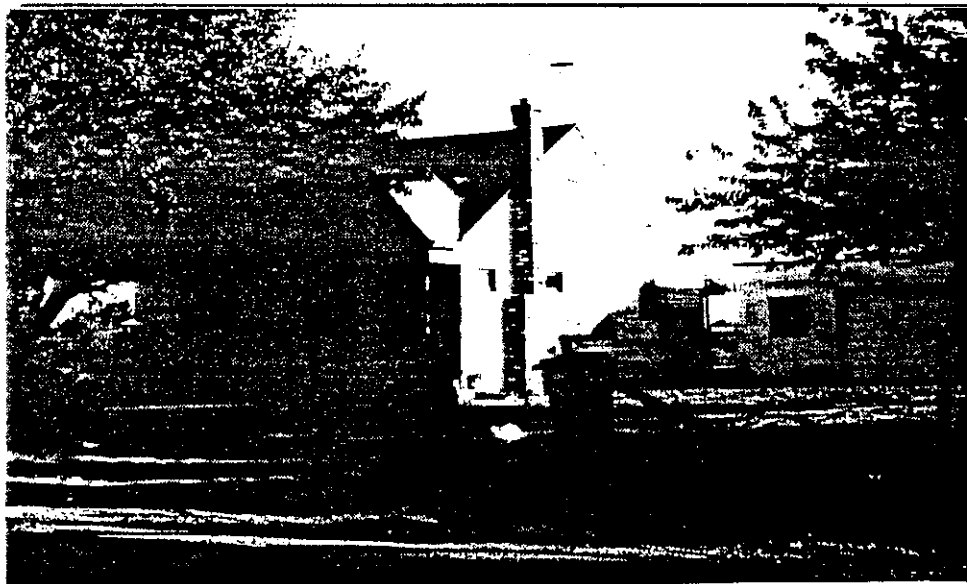
The county building record for this structure indicates a construction date of 1935. The variation of style and the date of construction place it in the Minimal Traditional style. Reflecting the era it was built, this Minimal Traditional house lacks the more expensive detailing of traditional Eclectic houses. Like other structures in this category, this house has a side gabled moderate pitched roof that extends into a shed roof in the rear. This one and one half story structure also has a gabled dormer extending over a partial porch. The roof is composition and the siding is wood.

A detached one-car garage sits adjacent to the house. This flat-roofed structure with stucco siding most likely was built concurrently with the house.

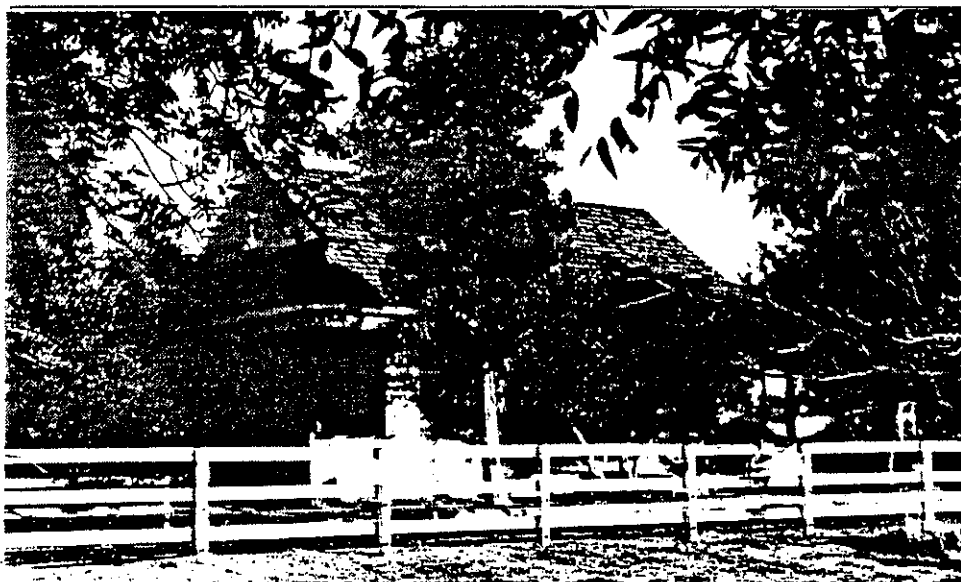
The county building record for this structure indicates a construction date of 1908. This house appears to be a one and one half story Queen Anne style cottage. The moderate pitched roof is front gabled and it extends at a hip-like angle to cover a partial porch. The hip roofed porch is supported by two classic columns. A second gable covers a cut-away bay. The main gable is covered with fish scale patterned shingles surrounding a gabled dormer. The gable above the cut away bay appears to be a mixture of fish scale and plain shingles surrounding a rectangular shaped window. Additional Queen Anne attributes include cut-away bays on both sides of the house, corner bracket detailing over the front bay, and simple door and window surrounds.

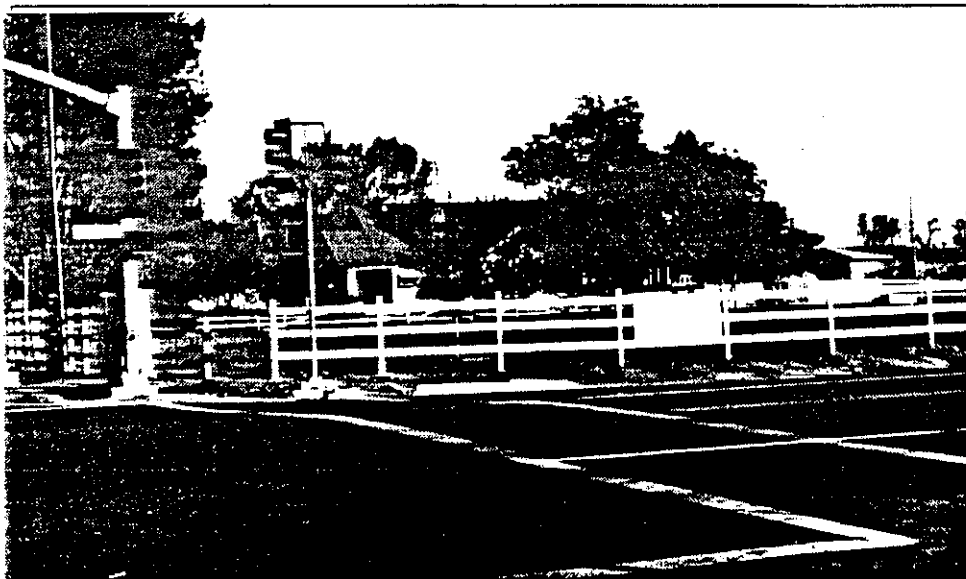
The county building record for this structure indicates a construction date of 1925 which is consistent with the style: Craftsman bungalow. The cross gabled, moderate pitched roof appears to be covered with composite shingles. Two piers with sloping sides extend from a short brick balustrade to support a gabled roof that is connected to the front gable of the house. Other typical Craftsman elements include exposed rafters and wood clapboard siding.

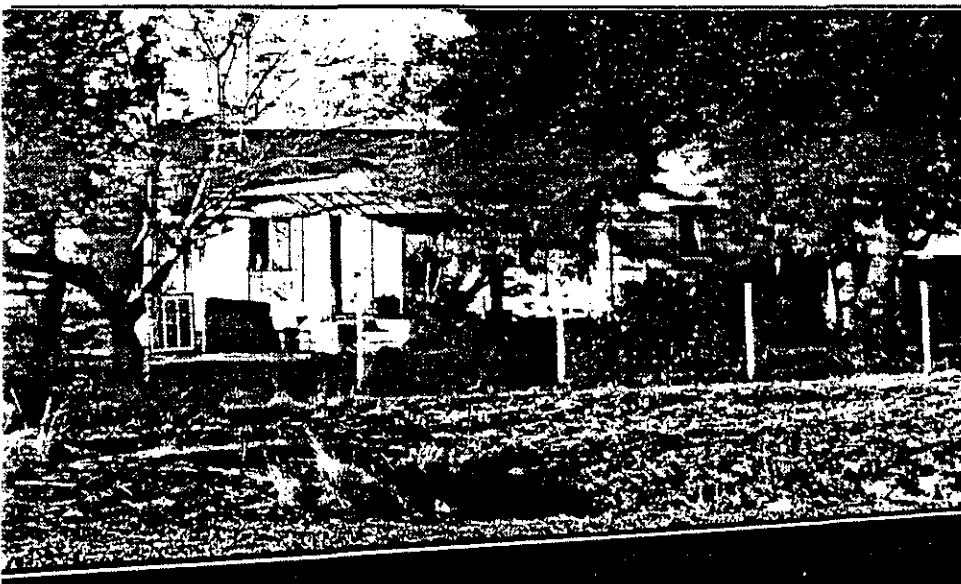
The county building record for this structure indicates a construction date of 1930. The house appears to have characteristics of the National Folk style but it is difficult to place in a distinct category. Some of its National Folk characteristics include the building's L shape with a moderate sloping cross-gabled roof and its shed-roofed porch placed within the L formed by the two wings. The roof is metal with standing seams and the walls appear to be smooth boards. The front windows and door have been replaced as well.

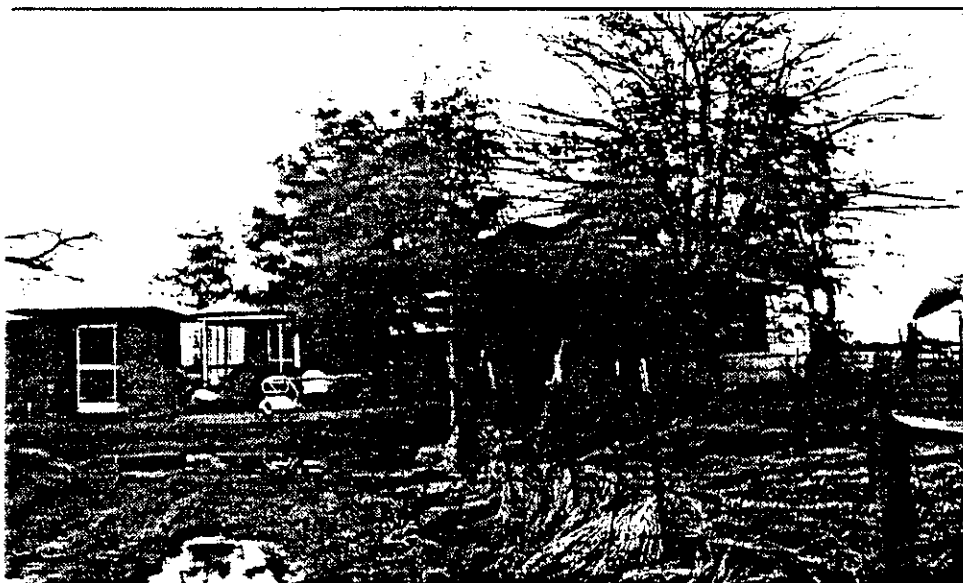
The county building record for this structure indicates a construction date of 1930. The house appears to have characteristics of the National Folk style but it is difficult to place in a distinct category. The building is L shaped with a cross-gabled roof. It appears that a section of this house may have been a later addition. A gabled pediment covers a partial porch on the front (east elevation) of the house. The other section of the house appears to have a wrap porch that is covered by an extended roof. Both porches are supported by plain wooden supports. The entire structure appears to be roofed in composition shingles but the siding is different. The front section is clad in clapboard siding and the second section appears to be covered in modern T/1/11 siding.

Two modern looking outbuildings are located near the structure. A small flat-roofed shed sits south of the structure and a cross-gabled garage sits southeast of the house. The roof of the garage appears to be corrugated metal and the siding appears to be T/1/11.
